FAILURE ANALYSIS OF SAMSUNG NOTE 7

JANUARY 23, 2017

UL & THE SCIENCE OF BATTERY SAFETY

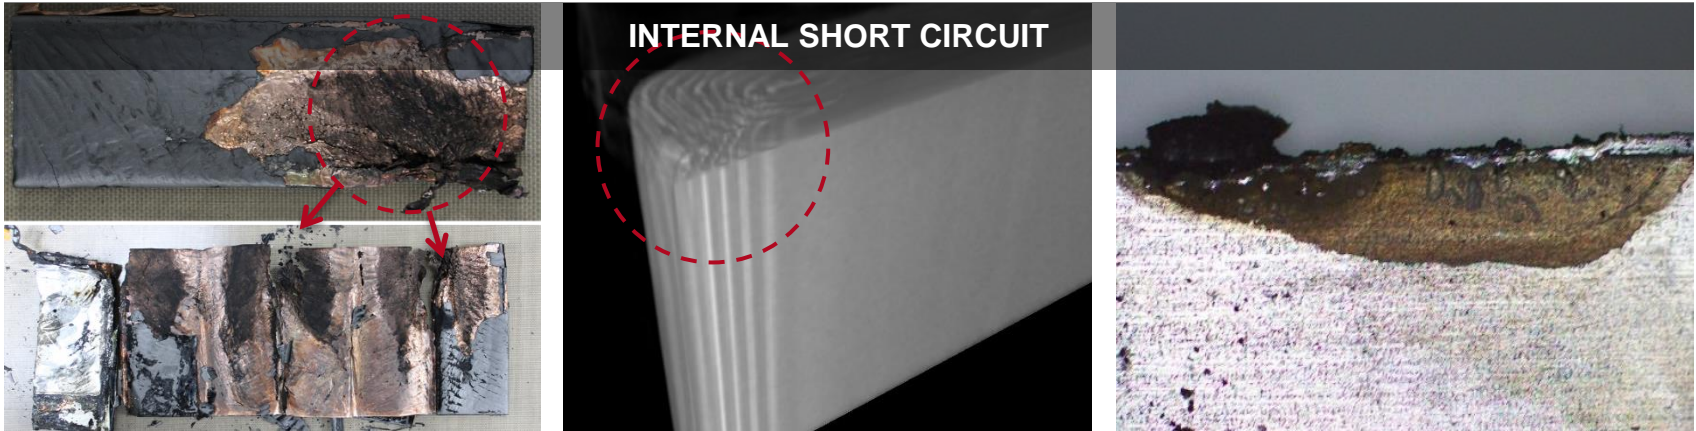
- Signs of internal short circuit (ISC) at the upper right corner of the cells from 6 damaged devices
- Signs of ISC at the upper right corner of 4 swollen cells

A combination of deformation at the upper corners + thin separator + repeating mechanical stresses due to cycling, causing higher possibility of separator damage leading to an ISC between aluminum and copper foil at the corner
- III. Additional investigation is needed to understand the root-cause of the deformations at the upper corners

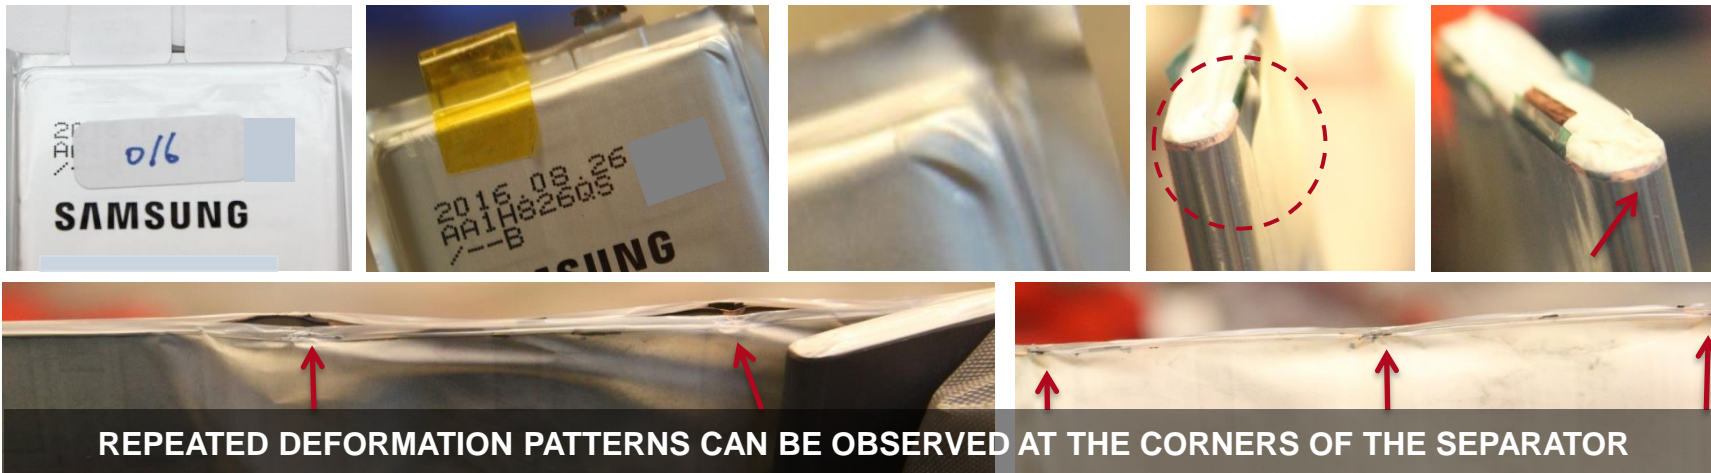
- CT scan of 30 cells and disassembly of 20 cells found only minor anomalies such as small void/bubble or uneven stress.
- Samples show a similar pattern of deformation at upper corners. Upper right corner deformation appears to be deeper than upper left.
- Tear down analysis shows repeating deformation areas on separator at the corner locations.

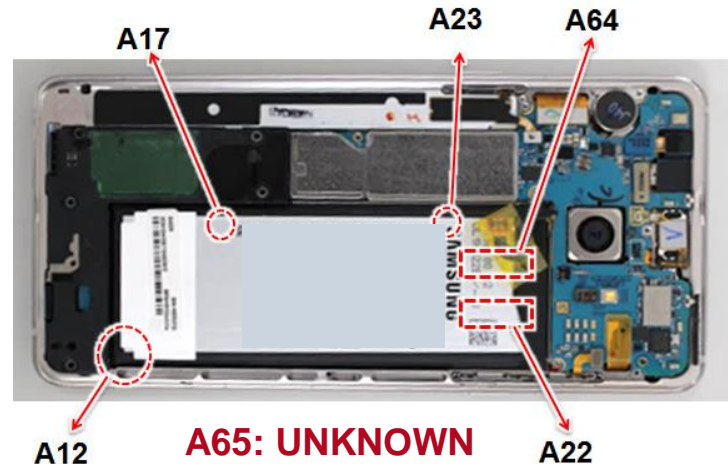
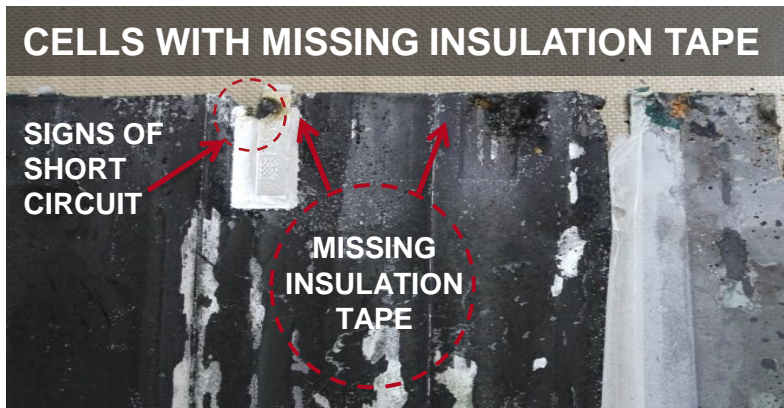
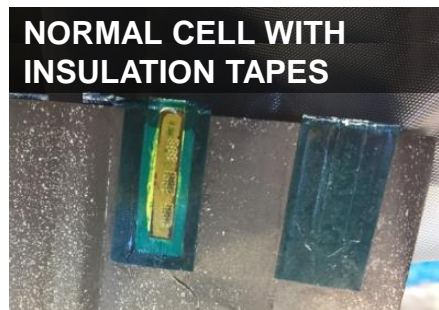
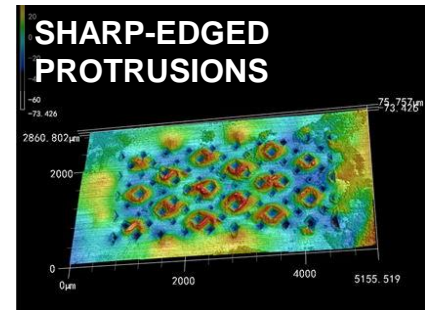
- Signs of internal short circuit (ISC) at different locations of the cells from 5 of the damaged devices
- Signs of ISC at the tab locations of swollen cells
- Missing insulation tape on the cathode of swollen cells
- Sharp-edged protrusions on the tab welding spots of swollen cells

The combination of (1) missing insulation tape + (2) sharp edged protrusions on tab + (3) thin separator, all leading to a high possibility of an ISC between cathode tab and anode, subsequently resulting in heating and fire

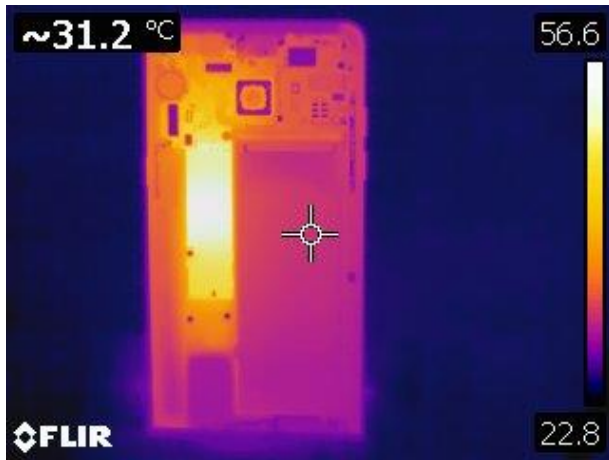
- Note 7 components do not increase the battery cell temperature to a level higher than the specified threshold

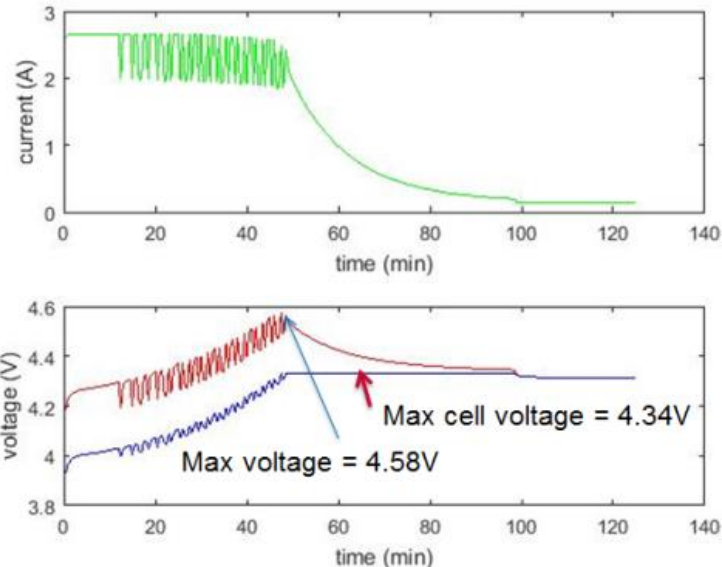
- Note 7 maximum current drain meets the specifications provided by Samsung
- The maximum charging current, the maximum temperatures and the maximum cell voltage are within the specifications with the standard adapter provided by Samsung

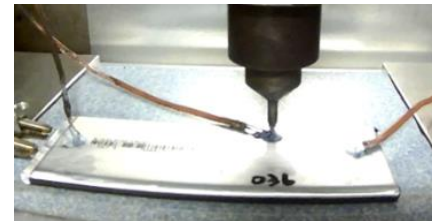
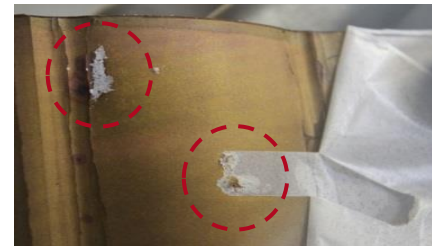
- The failure mode (ISC in winding edge) observed in field event samples can be reproduced by UL's ISC or localized heat pad tests
- Flaws were readily found from 3D CT scan of some samples
- Tear-down analysis findings include:
 - Uneven charge status on multiple samples
 - Signs of internal short circuit
 - Poor alignment and inconsistent shape and dimension of tabs and insulation tapes
 - Sharp edge protrusion of welding joints
